# **Construction Completion Report**

## **Beal Mountain Mine Pond Removal and Run-On Control Reclamation Project Silver Bow County, Montana**

January 2013

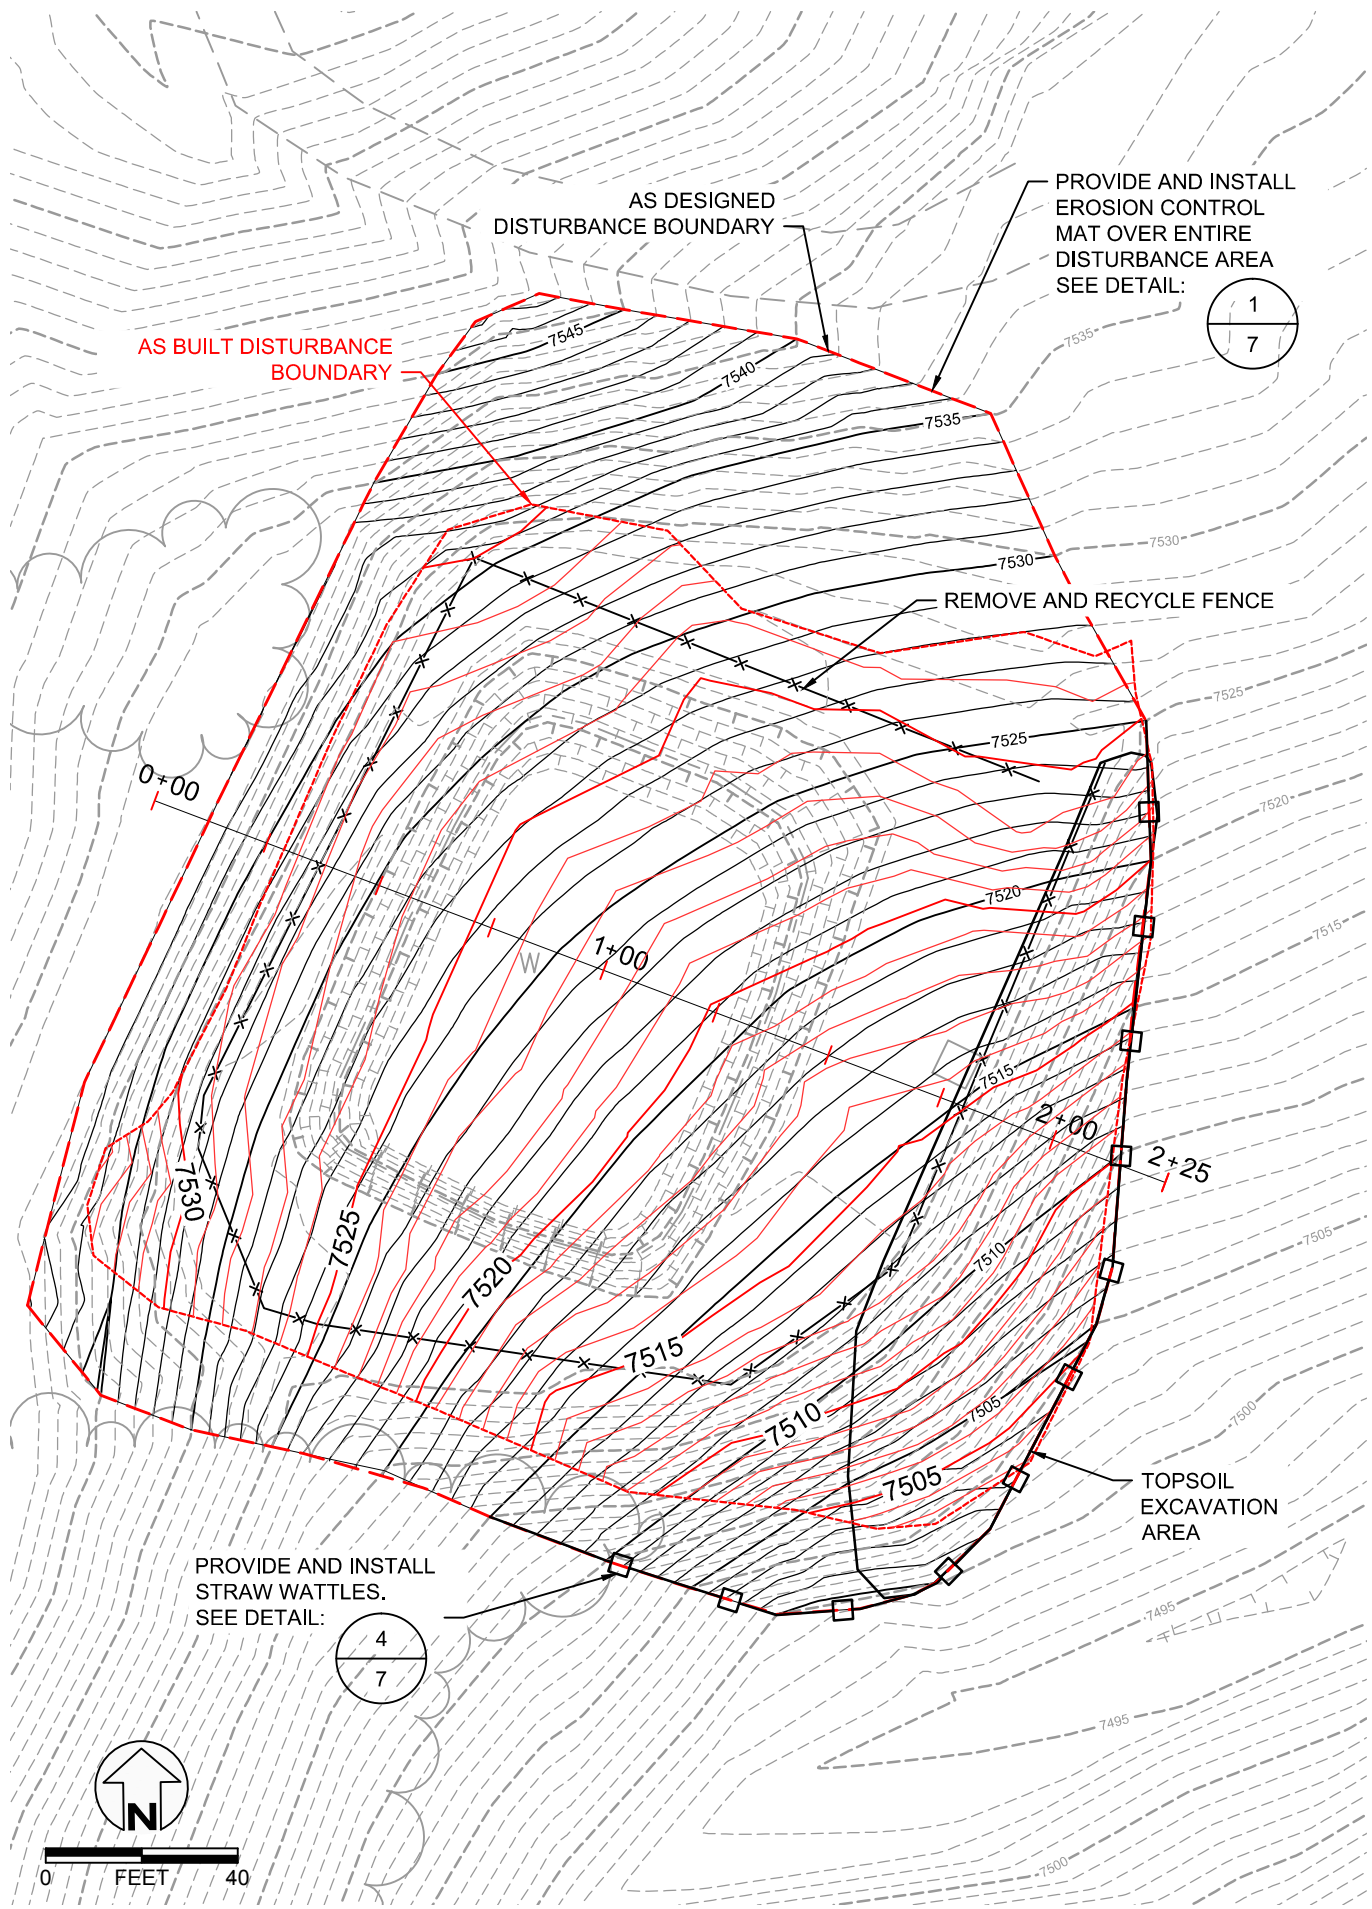
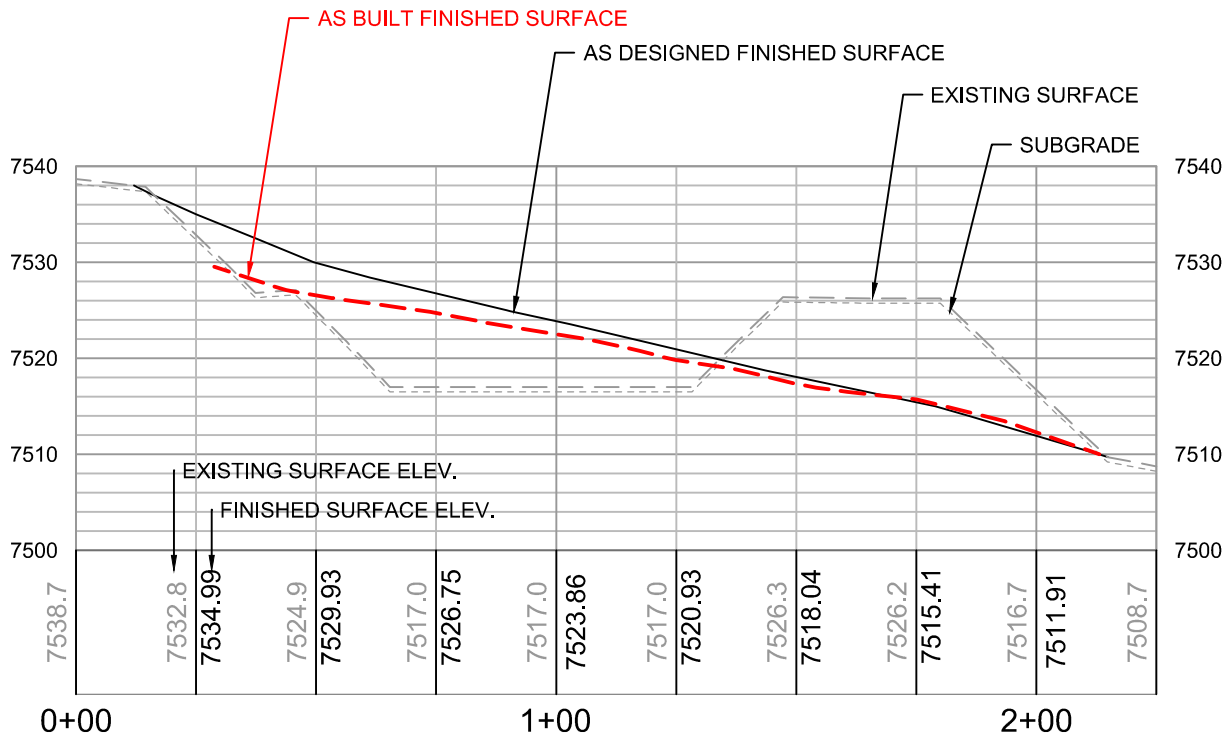
1 PROFILE VIEW - MINNESOTA POND  
VERT SCALE = 2X

Reclamation of the Minnesota Pond began on August 14, 2012, with dewatering of the Pond and removal of the perimeter fencing. Material originally excavated for Pond construction was then regraded to match the pre-mining topography as shown on Sheet 3 of the as-built drawings, **Appendix A**.

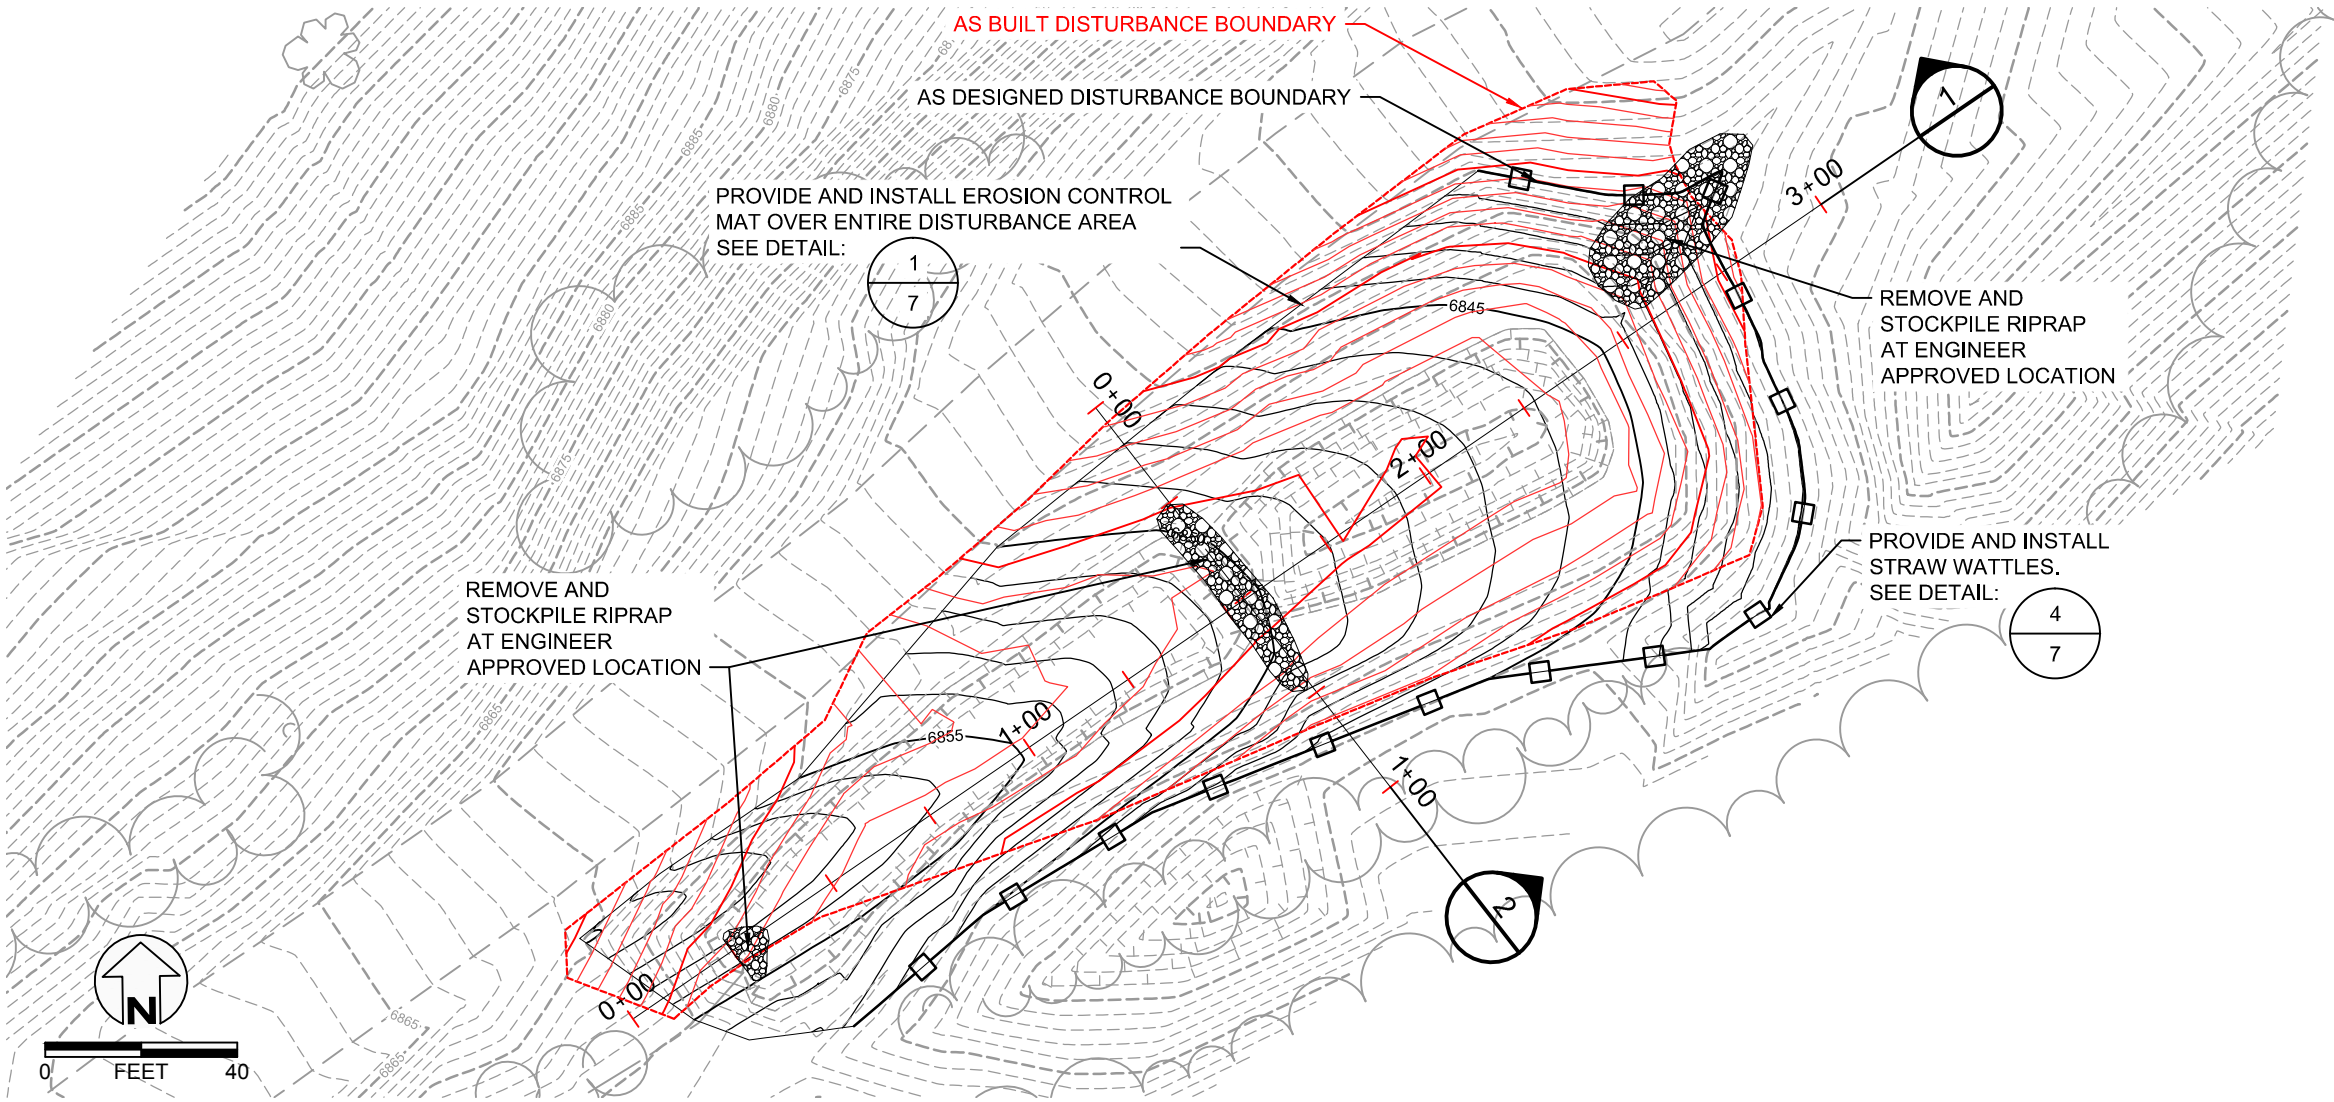
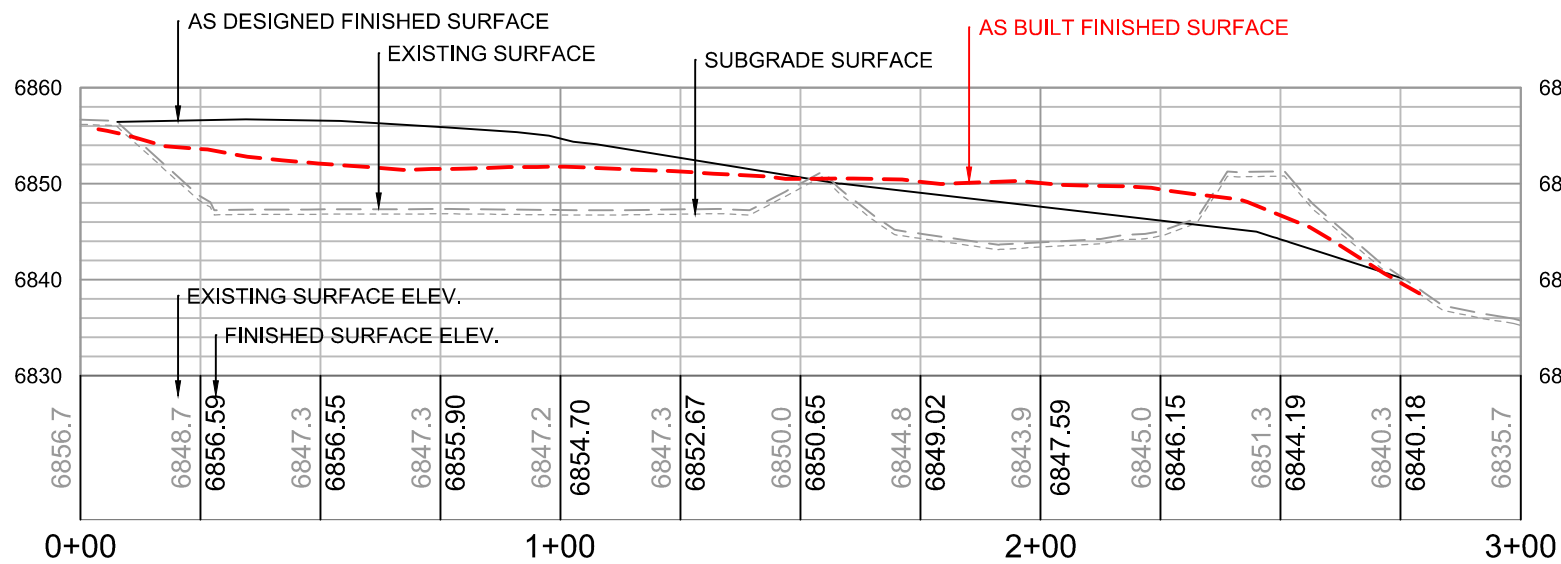
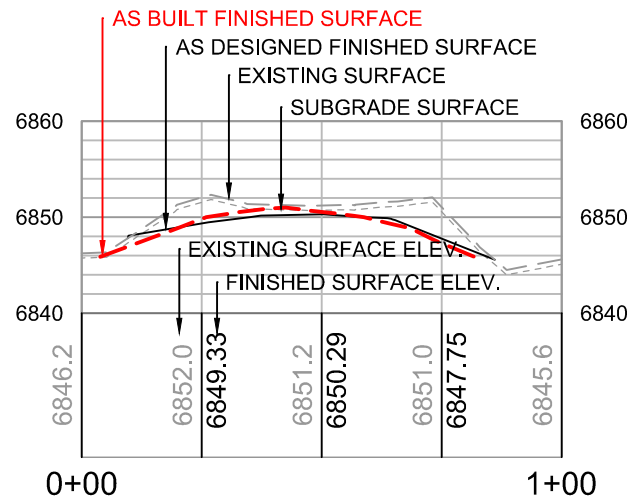
1 PROFILE VIEW - STORM WATER  
VERT SCALE = 2X

Work was then initiated concurrently at the Stormwater and Contingency Ponds. Schnell regraded a portion of the Stormwater Pond but chose to leave some material for potential use as backfill at the Contingency Pond in the event there was a deficit of material there. Work then focused on the Contingency Pond with removal of the pond liner and fencing materials. On August 23, 2012, Work Directive Change No. 2 was signed. This added removal of the check dam associated with the Contingency Pond and restoration of the German Gulch stream channel. Pond regrading and stream channel restoration work was completed on September 5, 2012.

Schnell then returned to the Stormwater Pond and regraded some of the material intentionally left there. Excavation of the run-on control ditch started on September 12, 2012. Liner was placed in the ditch on September 27, 2012. Imported cover soil was used as vegetative backfill in the ditch which was then fertilized, seeded, and covered with turf-reinforcement mat.

After completing the run-on control ditch, Schnell returned to the Stormwater Pond and continued regrading until the surface was acceptable to the QA team. Finally, seeding and fertilizing was completed by subcontractor Ueland-Western Reclamation. Schnell finished the Project by installing erosion control mat over all disturbed areas. **Table 1** lists construction milestones accomplished during the Project.

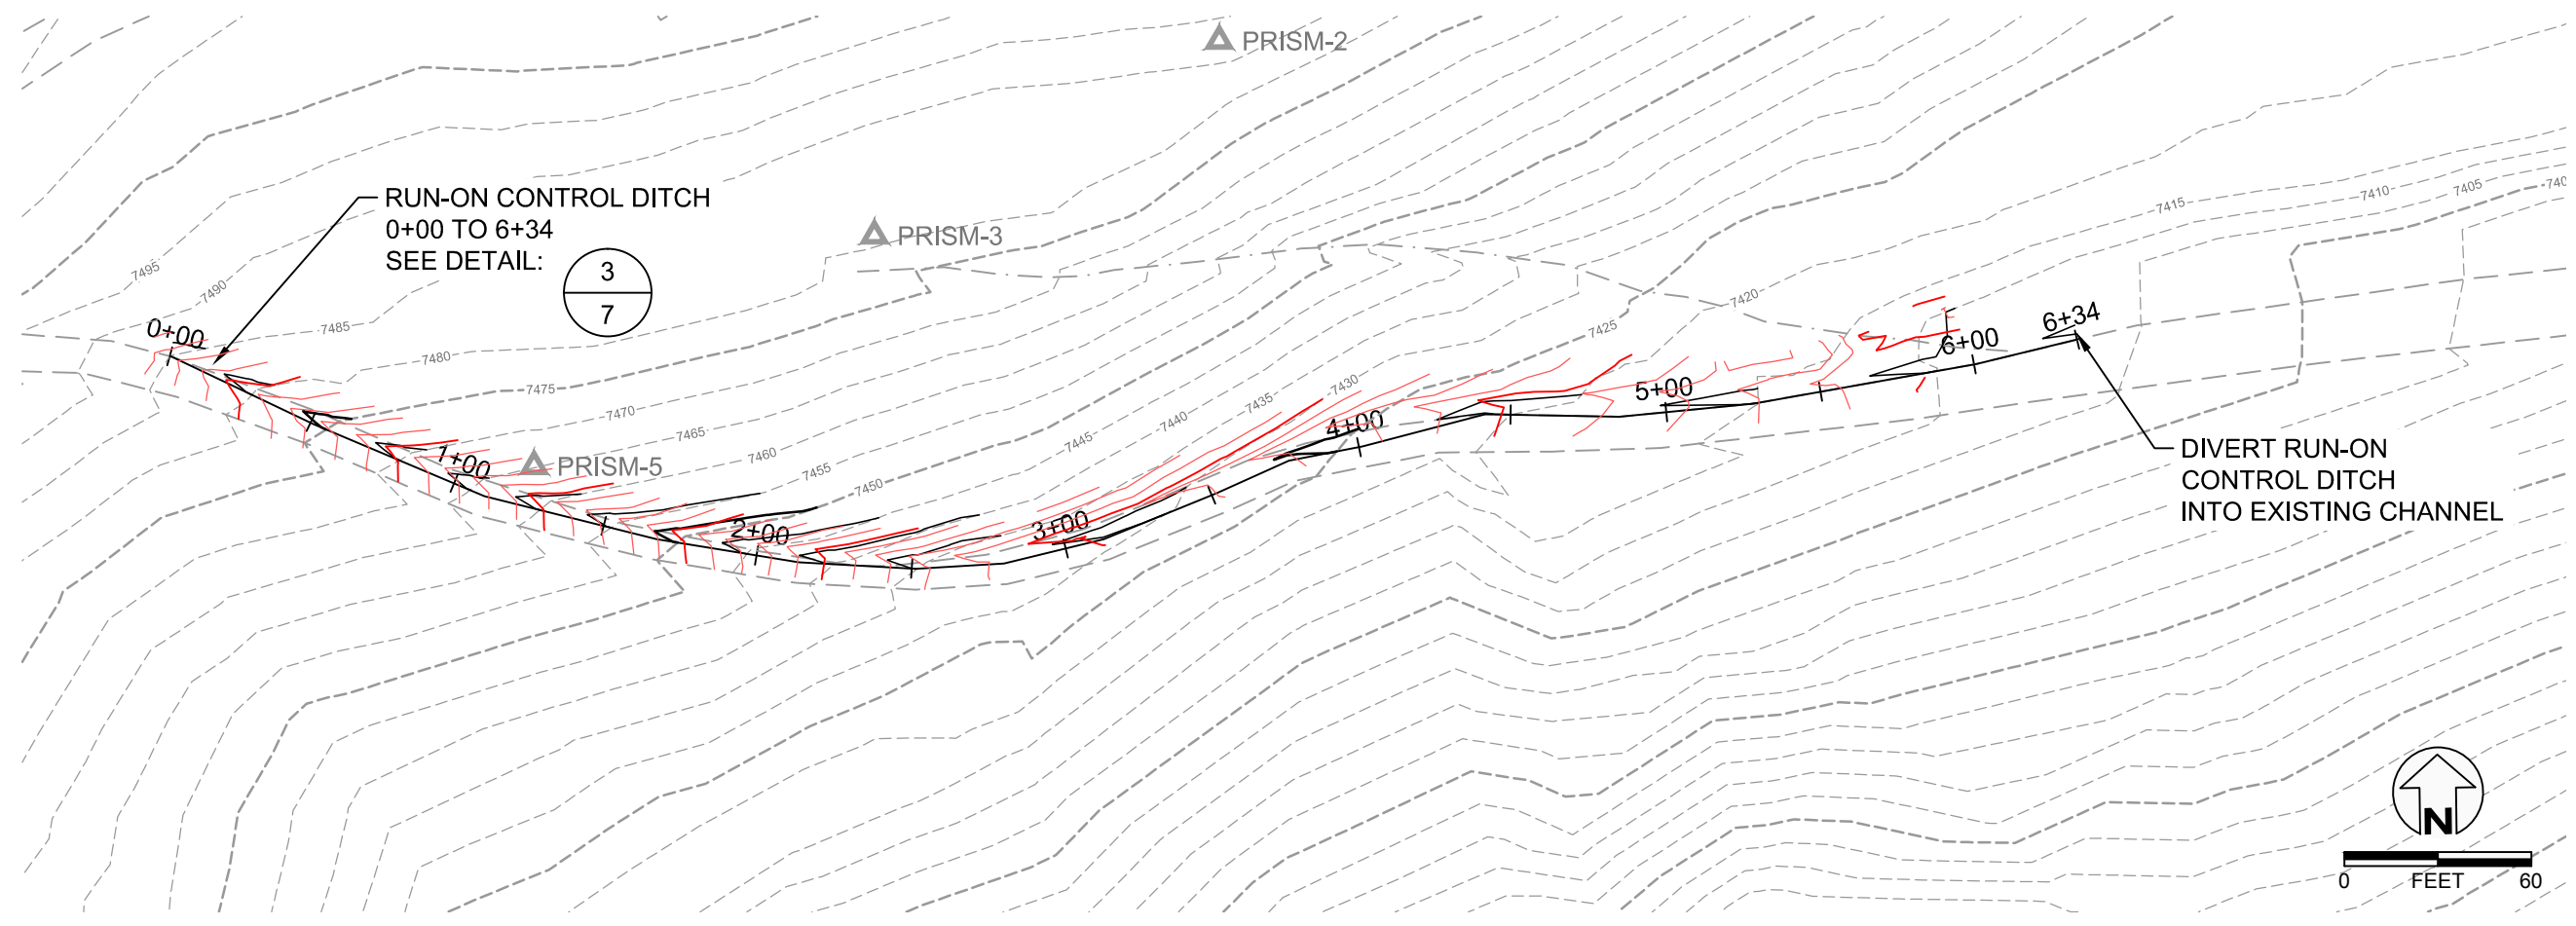
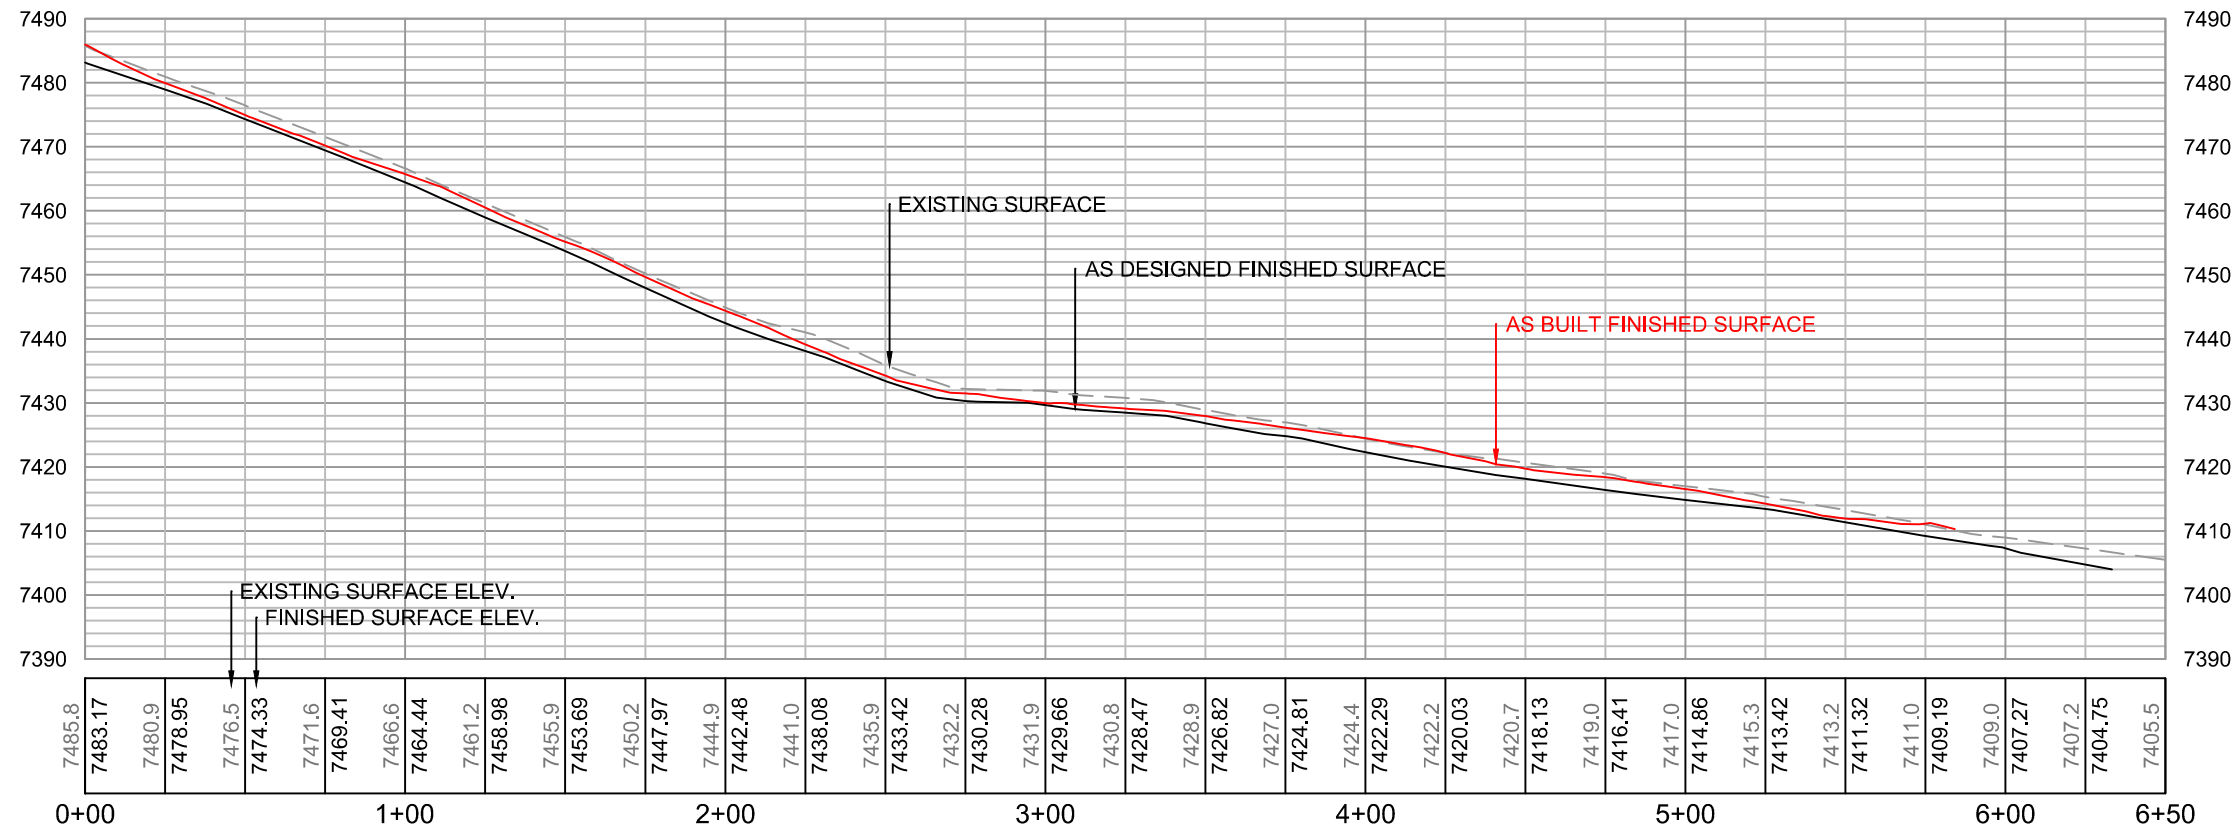
1    PROFILE VIEW - 0+00 TO 6+34  
--    VERT SCALE = 2X

On August 13, 2012, Brown and Associates (Brown) attempted to stake the run-on control ditch according to the channel alignment table on Sheet 9 of the Contract Documents. Once in the field, Brown encountered serious discrepancies between the elevations in the channel alignment table and the true elevations on the ground. Additionally, the horizontal alignment (i.e. channel centerline) was situated in the middle of the access road. Due to these problems, a decision was made by the QA team to move the centerline of the ditch to the toe of the road cut slope. Additionally, no cut and fill staking was completed because the channel centerline had been moved and the vertical controls were unusable. Therefore, Schnell was instructed by the

QA team to “field-fit” the ditch using the typical drawing shown on Sheet 7 of the Contract Documents as a guide. Ultimately, the field fitting process resulted in a ditch that was different from the design. The constructed ditch is generally shallower than the typical drawing and does not have the gradient depicted on the design drawing. This design change is displayed on Sheet 6 of the As-Built Drawings (**Appendix A**).

The contract drawings for the Run-On Control Ditch construction, (Sheet 6) of the Contract Documents, contained errors in the existing topography. This resulted in having to construct the ditch by “field-fitting” because no vertical and horizontal control staking could be established. Field fitting the ditch proved a cumbersome task and required multiple field meetings between Schnell and the QA team in order to reach agreement on the final product.

For future contracts at Beal Mountain Mine, it is recommended that pre-design surveying be completed for any areas thought to have errors in the existing survey information. Additionally, if a work item is known to require surveys for determining construction quantities (e.g. pond regrading), it may make sense to complete an initial survey as part of the engineering design process instead of waiting until construction is imminent.

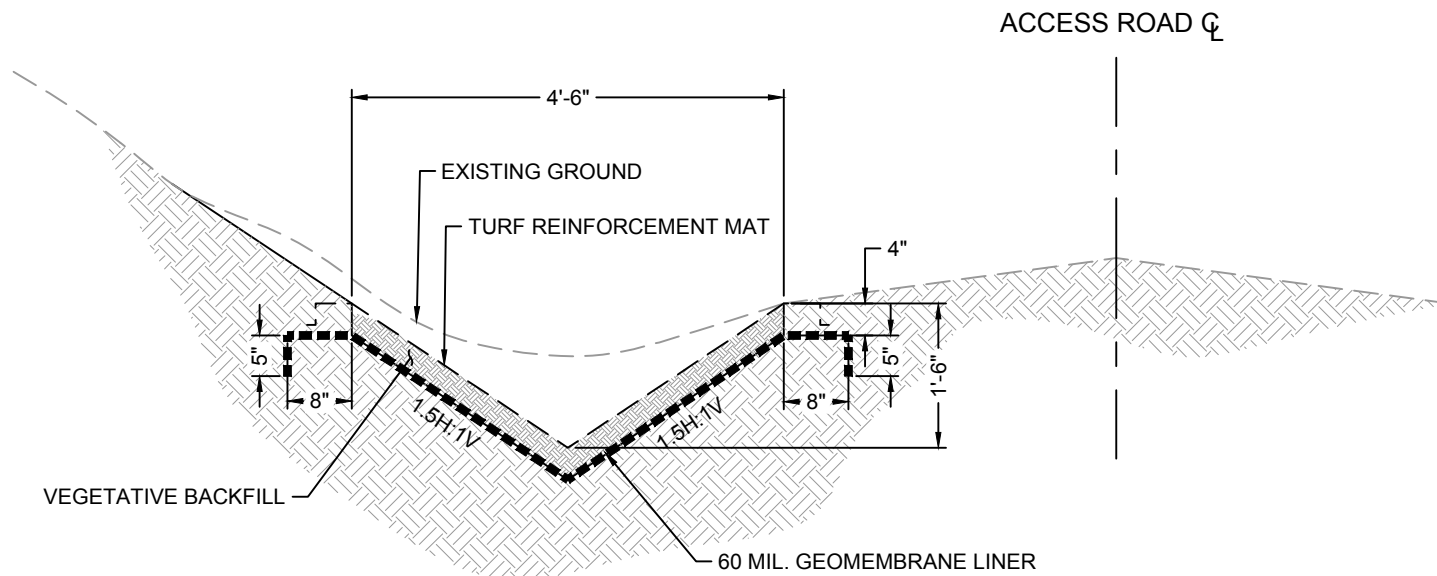
3  
7 RUN-ON CONTROL DITCH 0+00 TO 6+34  
NOT TO SCALE

- NOTES:**
1. RUN-ON CONTROL DITCH DOES NOT FOLLOW DIMENSIONS AS DISPLAYED IN DETAIL 3, RUN-ON CONTROL DITCH 0+00 TO 6+34, DUE TO SITE CONSTRUCTION LIMITATIONS AND CUT SLOPE CONDITIONS.
  2. KEY TRENCHES WERE NOT CONSTRUCTED IN ACCORDANCE WITH DETAIL 3, RUN-ON CONTROL DITCH 0+00 TO 6+34 DUE TO CONSTRUCTION LIMITATIONS.
